FIELD DIAGNOSTIC TESTING OF POWER GENERATORS AND TRANSFORMERS USING MODERN TECHNIQUES

Abstract

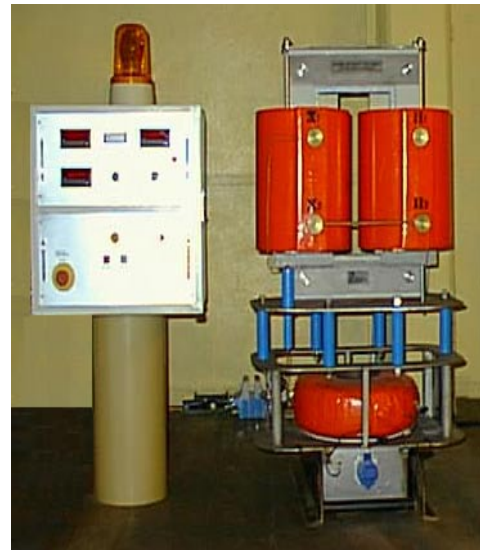
Fig. 1 Variable frequency resonant transformer

A variable frequency resonant transformer was especially designed and built for stator winding testing. The fixed high voltage reactor is made of two coils encapsulated in epoxy resin. The coils can be connected in series or in parallel, depending on the type of generator under test. An output voltage

of 30 kV can be obtained with both windings in series on a turbogenerator winding (300 nF load). An output voltage of 15 kV can be supplied to a load of 2 μF (large hydrogenerator).

The variable frequency supply was made of a three-phase rectifier with a filter and a single-phase inverter. The output frequency can vary from 40 to 120 Hz. The output voltage is controlled with the width of the pulse of the variable frequency electronic source. This is an advantageous feature because it reduces considerably the weight and size of the resonant transformer. The variable frequency resonant transformer is shown in Fig. 1.

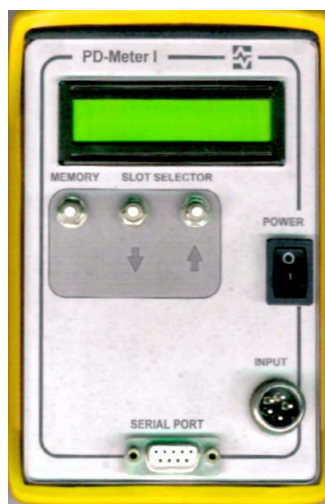
Fig. 2 Digital slot discharge meter with storage capabilities

A discharge probe with digital storage capability was designed to ease the recording of the discharge level of each slot. The equipment stores the discharge level of three generator positions, (the exciter side, the turbine side and one in the middle area of the stator). Data is unloaded to a personal computer through a serial port. A view of this instrument is shown in Fig. 2.

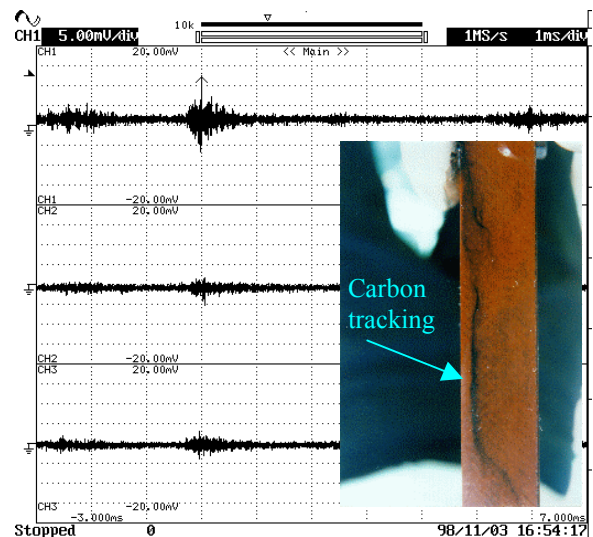
Fig. 7 Oscillograms from a deteriorated diverter switch. Damaged insulated support is also shown.

CASE 2. It was programmed an ultrasonic test on a single-phase 100/125 MVA, 400/230/13.8 kV autotransformer, as part of the maintenance program. High ultrasonic activity was detected on the wall of the main tank adjacent to the "On-Load Tap Changer (OLTC). Typical signals are shown in Fig. 5. The PD activity came mainly from the region of the OLTC diverter switch tank. As an additional test, DGA was performed to the diverter switch oil. Results indicated slightly abnormal values, considering the reduced number of operations made.

The OLTC was disassembled for inspection and the pressboard insulated structure that supports the diverter switch mechanism was found very deteriorated with carbon tracking. The degradation was originated in the neutral connector. Fig. 8 shows one of the deteriorated insulated supports where tracking can be observed.
